# CERTIFICATE OF SUBSTANTIAL COMPLETION

PROJECT: Otter Creek Clubhouse and  
(Name and address) Community Building  
Otter Creek Golf Course  
Ankeny, Iowa

## Punch List

To: Dave Carlson  
From: Jim Harbaugh  
Subject: Otter Creek Punch list  
Date: 6/17/09

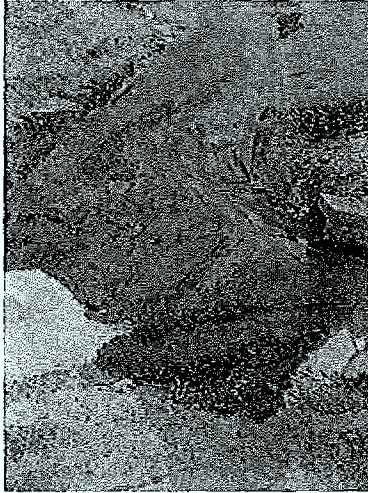
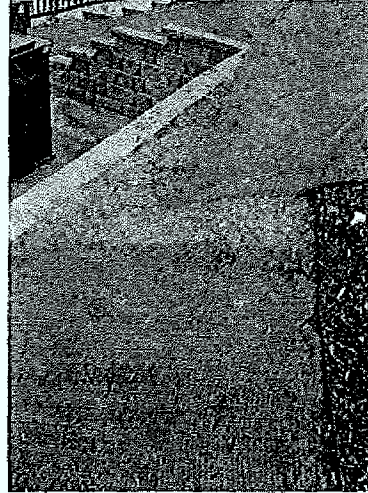
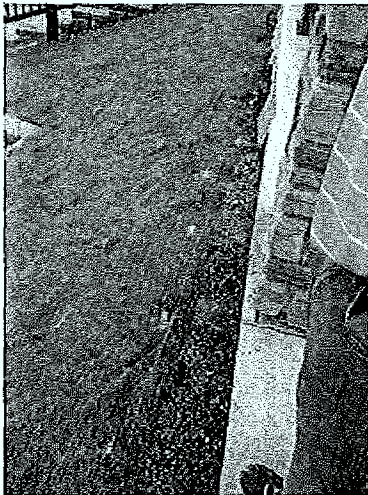
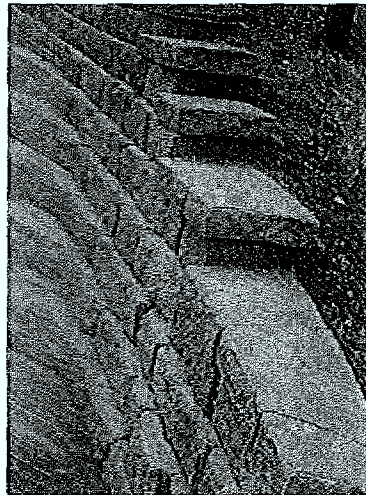
12. Rocks and debris were not picked up on the east slope prior to seeding operations.
13. Please verify that starter fertilizer was used in all seeding operations.
14. The block wall around the transformer needs to be fixed and caps adhered to the wall top.
15. Backplaster the edge of the sidewalk on the east side of the building above the transformer.

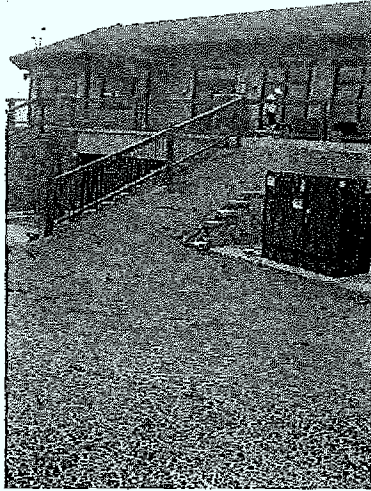
16. More fill material is required along the slope of the eastern sidewalk north of the cart entryway. The top of slope is 6-12" lower the same slope of the sough side of the cart path.

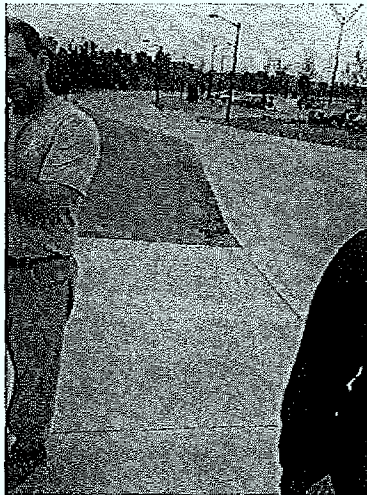
17. Touch up seeding and mulch in areas that were not drilled or did not germinate. This is especially evident along roadway and walkway edges where the seeder did not get close to the paving with the seed drill. If it cannot be drilled adjacent to paving, then it must be broadcast and mulched.

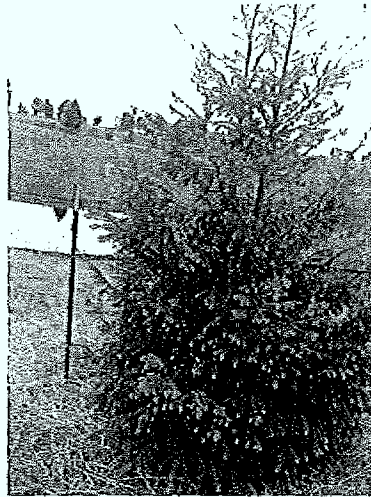
21. Adjust valve box elevations along entrance roadway.
22. On the eastern side of the entrance road there is an evergreen with a double leader. Replace evergreen.
